Our Reference: 23845:NB1733

RE: LEVEL 1 EARTHWORKS INSPECTION AND TESTING
105 SMITHS LANE – STAGE 42 (CLYDE NORTH)

Project Details: SMITHS LANE
STAGE 42
CITY OF CASEY, R5852

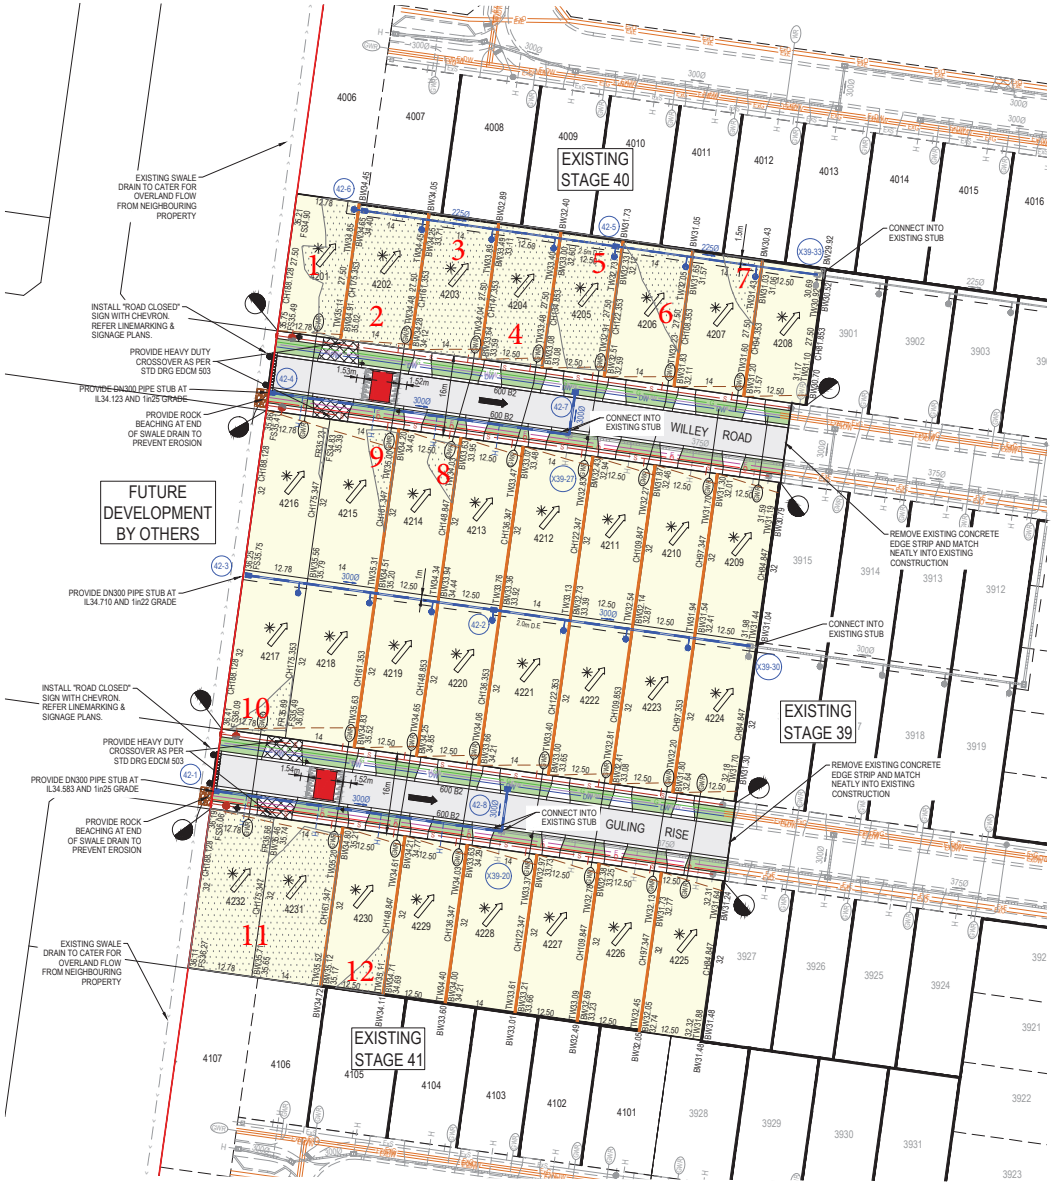
FIGURE 1

The site inspection and testing was performed by experienced geotechnicians from this office. Any areas that were deemed unsatisfactory were reworked and retested under their supervision. The testing was performed to the relevant Australian Standards and the accompanying test reports carry NATA endorsement. The attached compaction results, which were located randomly throughout the fill profile, are considered to be representative of the bulk fill materials that were placed across the reported allotments by Winslow Constructors during the aforementioned period. The approximate locations of the field density tests can be seen on the attached plan (Figure 1).

We are of the view that the bulk fill materials that have been placed across the reported allotments by Winslow Constructors during the aforementioned period can be considered as having been placed in a controlled manner to a minimum density ratio of 95% (standard compactive effort).

Approximate field density test location
